**Flood Control Project Maintenance
Levee Inspections**

Fall 2018 Levee Maintenance Deficiency Summary Report

Reclamation District No. 0827 Elkhorn

Levee Inspection Report By Mile - Fall 2018

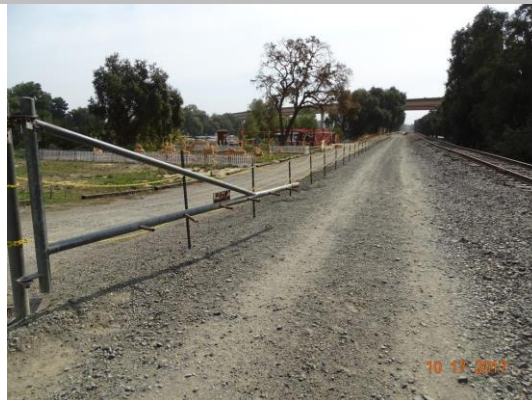
Photo 1 of 1 : FA_2018_RD0827_187_16_20180904_00011.jpg

LM Start	0.03	Rating **	M	Issue No.	16
LM End	0.15	Issue Type +	En	Location *	CR
Category	Earthen Levee			GPS Latitude/Longitude	
				Start	End
Item	Encroachments			38.674881 °	38.673668 °
				-121.630109 °	-121.628490 °
DWR ID	DWR_RD0827_01_f_2017_16				
Comment Code					
FE : Fence					
Inspector Comment					
Fence installed by adjacent tourism company. Submitted a FIR to the CVFPB.

View of fence on crown. Fall 2017.

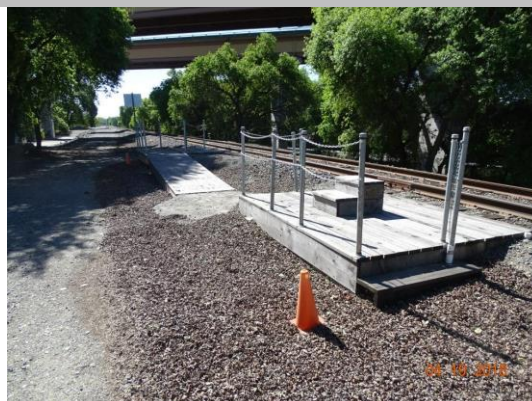
Photo 1 of 2 : FA_2018_RD0827_187_10_20180904_00005.jpg

LM Start	0.14	Rating **	M	Issue No.	10
LM End	0.14	Issue Type +	En	Location *	CR
Category	Earthen Levee			GPS Latitude/Longitude	
				Start	End
Item	Encroachments			38.673767 °	38.673767 °
				-121.628593 °	-121.628593 °
DWR ID	DWR_RD0827_01_f_2018_10				
Comment Code					
ST : Stairway					
Inspector Comment					
Railroad has put steps on the crown for the tourist train from the West City of Sac water plant. Stairs are not permitted and was placed Spring 2016. The railroad has added a wheelchair access ramp. Subbited a FIR to the CVFPB.

View of the existing stairs and new ramp. Spring 2018.

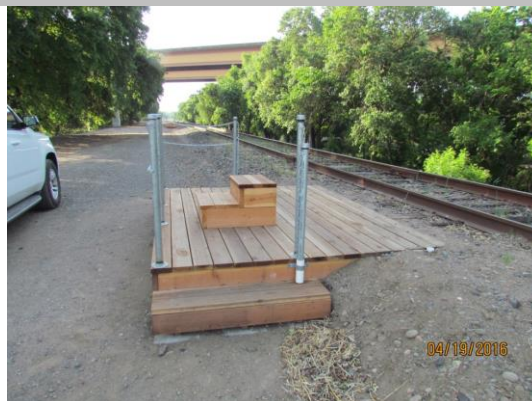
Photo 2 of 2 : FA_2018_RD0827_187_10_20180904_00006.jpg

View of the stairs on the crown of the levee looking downstream. Spring 2016.

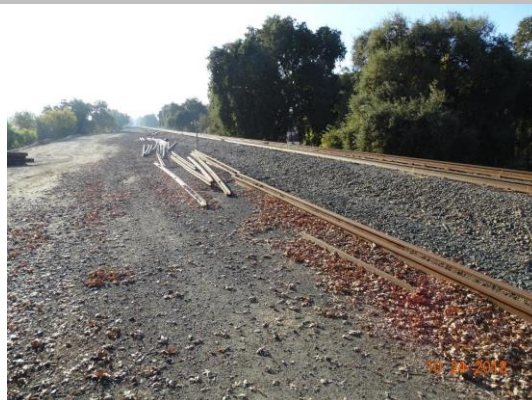
Photo 1 of 2 : FA_2018_RD0827_187_12_20181025_00017.jpg

LM Start	0.24	Rating **	M	Issue No.	12
LM End	0.58	Issue Type +	En	Location *	CR
Category	Earthen Levee			GPS Latitude/Longitude	
				Start	End
Item	Encroachments			38.672749 °	38.669200 °
				-121.627333 °	-121.622851 °
DWR ID	DWR_RD0827_01_s_2016_12				
Comment Code					
MA : Material					
Inspector Comment					
RR rails and ties on the levee crown.

Updated view of railroad ties on the crown. Fall 2018.

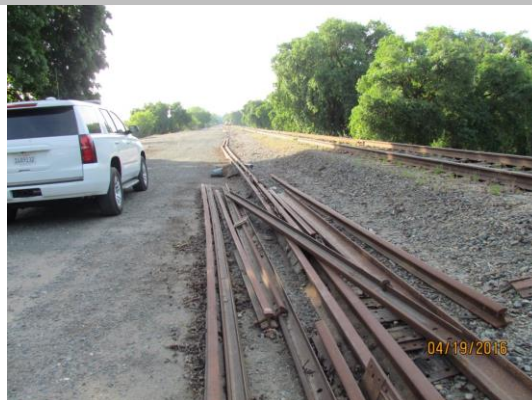
Photo 2 of 2 : FA_2018_RD0827_187_12_20180904_00007.jpg

View of the rails on the crown of the levee looking downstream. Spring 2016.

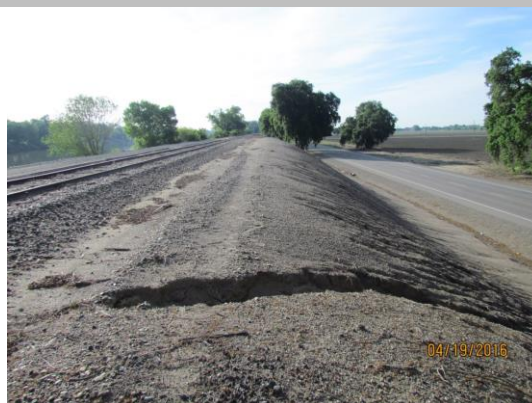
Photo 1 of 2 : FA_2018_RD0827_187_13_20180904_00008.jpg

LM Start	0.51	Rating **	M	Issue No.	13
LM End	0.51	Issue Type +	Ma	Location *	LS
Category	Earthen Levee			GPS Latitude/Longitude	
				Start	End
Item	Erosion / Bank Caving			38.669929 °	38.669929 °
				-121.623776 °	-121.623776 °
DWR ID	DWR_RD0827_01_s_2016_13				
Comment Code					
E2 : Schedule repair of erosion site prior to the next inspection.					
Inspector Comment					
Rills caused by rain.

View of the erosion on the landward side of the levee looking downstream. Spring 2016.

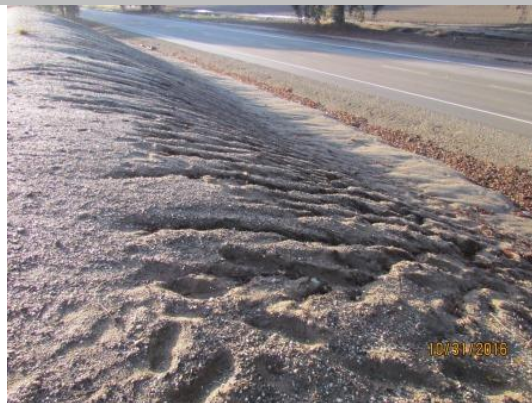
Photo 2 of 2 : FA_2018_RD0827_187_13_20180904_00009.jpg

Updated view of runoff erosion site. LS slope. Fall 2016.

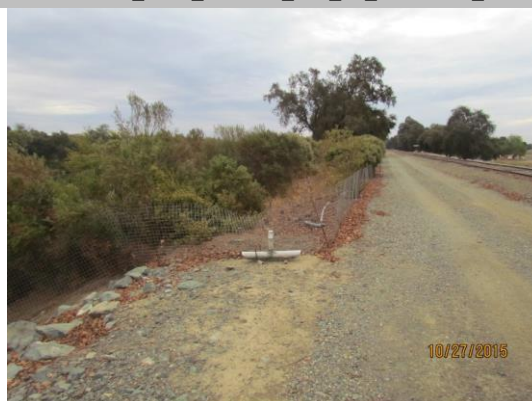
Photo 2 of 2 : FA_2018_RD0827_187_22_20180904_00013.jpg

View of the revegetation site on the waterward side of the levee looking downstream. Fall 2015.

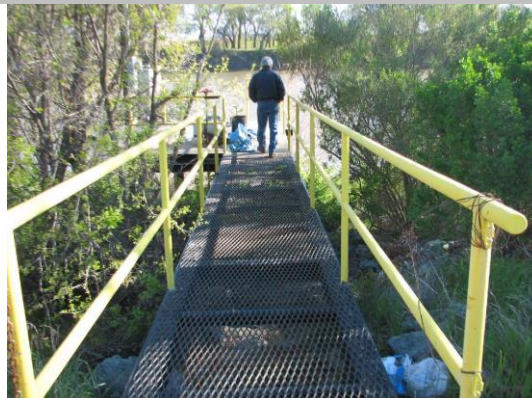
Photo 1 of 3 : UCIP_FA_2018_38983_59737.jpg

Comment Code						
Inspector Comment						
FS_ID:38983 DS_ID:21147 EP_NO: N/A Repair Type: Non-Urgent Crossing Status: Found UCIP Comments: Need to contact owner to obtain additional information for this crossing. This crossing does not match original description listed in desk study. Need to coordinate with owner to obtain permit number authorizing modification. FIELD_STRUCT_DESC: 14-inch (not 16-inch as listed in desk study) pipe through the levee, 10.3 feet below the crown. 10-inch bypass pipe on waterside (WS). Siphon breaker on landside (LS) (not WS) shoulder. Pump on platform (not mounted on 48-inch concrete pipe as described in desk study) on WS bank. Metal (not wooden) walkway to the pump. 3/4-inch conduit through levee at unknown depth. [Additional Reference(s): DWR Levee Logs, 2005] FS Date: 3/18/2014

Platform for pump located on waterward side.

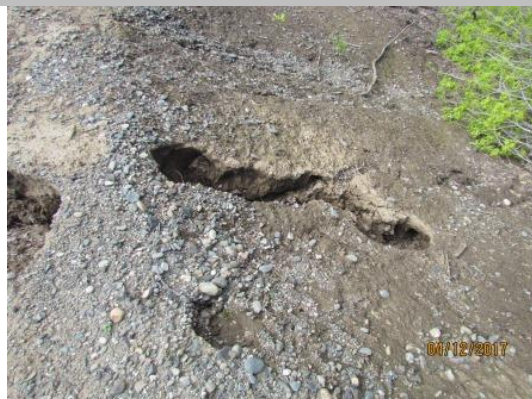
Photo 2 of 3 : FA_2018_RD0827_187_3_20180904_00002.jpg

Another view of erosion on levee slope. A hole on the waterside slope has widened due to runoff. Spring 2017.

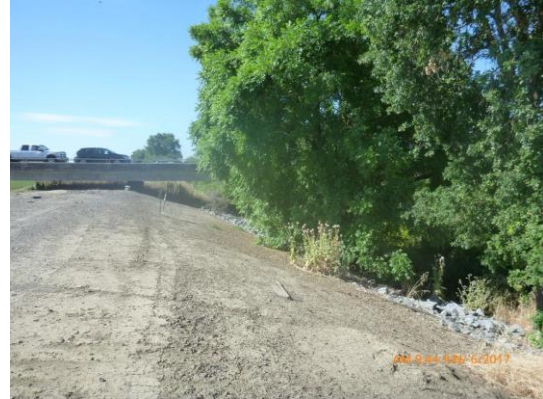
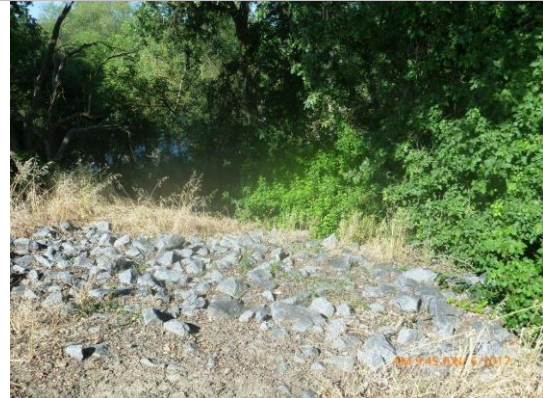
LM Start	0.15	Rating **	A/W	Issue No.	10
LM End	0.16	Issue Type +	Ma	Location *	
Category	Supplemental			GPS Latitude/Longitude	
				Start	End
Item	2017 Storm Damage			38.674778 °	38.674583 °
				-121.642806 °	-121.642722 °
DWR ID	DWR_RD0827_02_f_2017_10				
Comment Code					
Inspector Comment					
Levee Evaluation Comments					
Description:					
Site ID No:200					
Site Designation:RD 827-02					
Repair Type: Erosion					
Rating:Area of Concern					
Field Date:6/6/2017					
Notes: no damage visible, ws armored with riprap

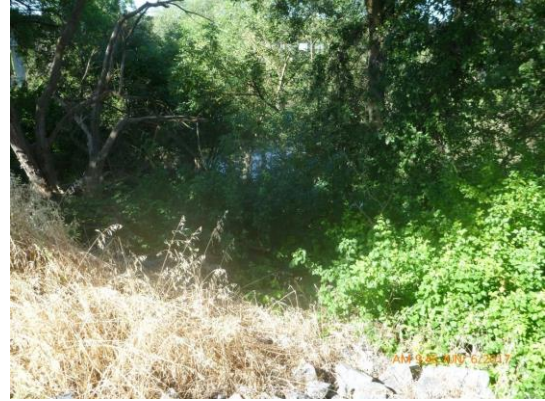
Photo 3 of 3 : LEVAL_FA_2018_200_1246.jpg

LM Start	0.15	Rating **	A/W	Issue No.	10 (cont)	
LM End	0.16	Issue Type +	Ma	Location *		
Category	Supplemental			GPS Latitude/Longitude		
				Start	End	
Item	2017 Storm Damage			38.674778 °	38.674583 °	
				-121.642806 °	-121.642722 °	
DWR ID	DWR_RD0827_02_f_2017_10					
Comment Code						
Inspector Comment						
Levee Evaluation Comments						
Description:						
Site ID No:200						
Site Designation:RD 827-02						
Repair Type: Erosion						
Rating:Area of Concern						
Field Date:6/6/2017						
Notes: no damage visible, ws armored with riprap

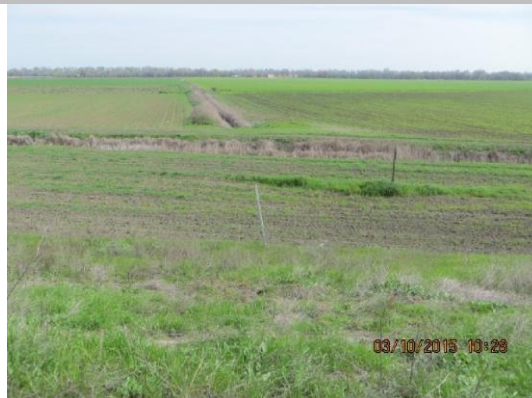
Photo 1 of 3 : UCIP_FA_2018_53087_73360.jpg

Comment Code					
Inspector Comment					
FS_ID:53087 DS_ID:21159 EP_NO: 15904 Repair Type: Non-Urgent Crossing Status: Indicator Found UCIP Comments: 10/25/2018 Markers on levee not found. Pipe not in use. Valve located on pipe bend near ditch on LS is shut down. Crossing has been downgraded to "Non-Urgent" due to reclassification of gas lines. (O.Yakimov - DWR) 8/31/2016 Meet with Greg Lucas, Assistant Production Coordinator from California Resources Corporation and Steve Steim from Noble Methan, Inc. to discuss the status of a different line upstream. Mr. Steve Steim was aware of the 3-inch line by Two Bay Petroleum as known as a PG&E old pipe at this location. According to Steve Stein the appurtenances previously located on the landside have been removed and the 3-inch line abandoned. Need to contact owner to confirm status of crossing. If crossing is no longer in use the owner will need to coordinate with CVFPB to comply with Title 23. (DWR UCIP - omagana)8/04/2016 No markers found on either WS or LS. Need to coordinate with owner to determine status of crossing. (DWR UCIP - omagana)3/10/2015 Sign missing on WS and LS. Need to confirm status of crossing with permittee. Appears abandoned. (DWR UCIP - wwylie) 03/18/2014 crossing not found. (DWR UCIP - omagana) FIELD_STRUCT_DESC: 3-inch steel gas pipeline through the levee, 20 feet below the crown. Sign on waterside (WS) (not found 2015). Yellow pipe visible east of ditch approximately 150 feet off landside (LS) toe. Contact Number 415-459-3445 for Two Bay Petroleum also referred as Pacific Energetics, Inc. (3-inch line authorized under Permit No. 15904, 1992 - Two Bay Petroleum) FS Date: 10/25/2018 10:29:07 AM

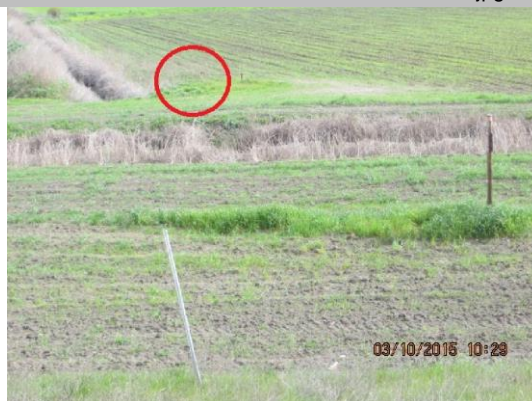
Photo 2 of 3 : UCIP_FA_2018_53087_73361.jpg

Comment Code						
Inspector Comment						
FS_ID:53087						
DS_ID:21159						
EP_NO: 15904						
Repair Type: Non-Urgent						
Crossing Status: Indicator Found						
UCIP Comments: 10/25/2018 Markers on levee not found. Pipe not in use. Valve located on pipe bend near ditch on LS is shut down.						
Crossing has been downgraded to "Non-Urgent" due to reclassification of gas lines. (O.Yakimov - DWR) 8/31/2016 Meet with Greg Lucas, Assistant Production Coordinator from California Resources Corporation and Steve Steim from Noble Methan, Inc. to discuss the status of a different line upstream. Mr. Steve Steim was aware of the 3-inch line by Two Bay Petroleum as known as a PG&E old pipe at this location. According to Steve Stein the appurtenances previously located on the landside have been removed and the 3-inch line abandoned.						
Need to contact owner to confirm status of crossing. If crossing is no longer in use the owner will need to coordinate with CVFPB to comply with Title 23. (DWR UCIP - omagana)8/04/2016 No markers found on either WS or LS. Need to coordinate with owner to determine status of crossing. (DWR UCIP - omagana)3/10/2015 Sign missing on WS and LS. Need to confirm status of crossing with permittee. Appears abandoned. (DWR UCIP - wwylie)

Pipe visible east of ditch approximately 150 ft off LS toe.

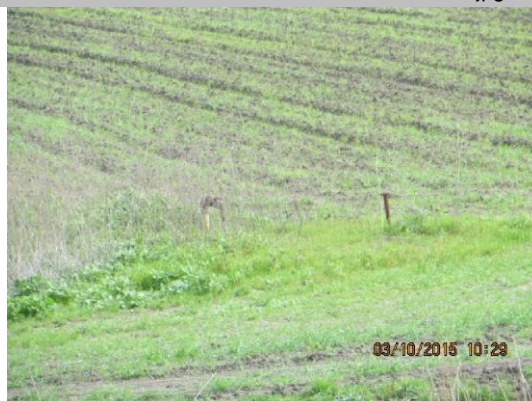
Photo 3 of 3 : UCIP_FA_2018_53087_73362.jpg

Yellow pipe visible off LS toe.

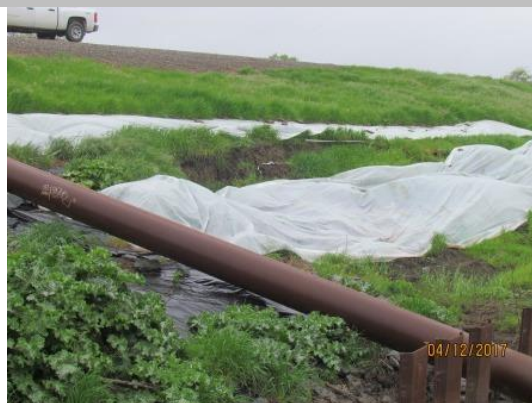
Photo 1 of 2 : FA_2018_RD0827_188_14_20180904_00008.jpg

View of erosion and visqueen on landside levee slope. Spring 2017.

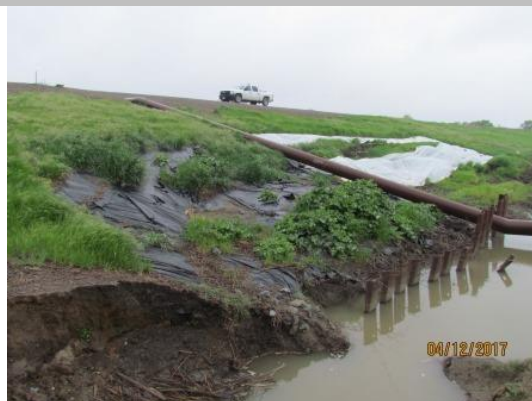
Photo 2 of 2 : FA_2018_RD0827_188_14_20180904_00009.jpg

Additional view of erosion on landside levee slope. Spring 2017.

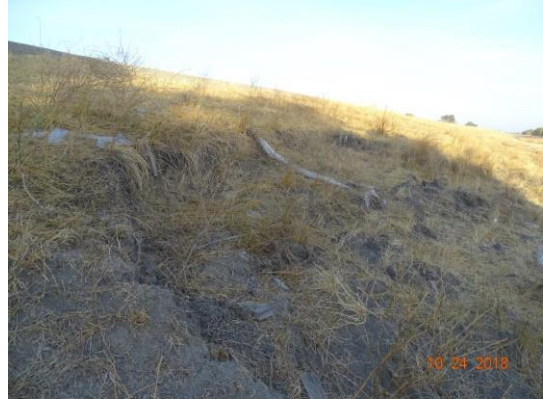
Photo 1 of 6 : FA_2018_RD0827_188_13_20181025_00023.jpg

LM Start	2.72	Rating **	M	Issue No.	13
LM End	2.73	Issue Type +	Ma	Location *	
Category	Supplemental			GPS Latitude/Longitude	
				Start	End
Item	2017 Storm Damage			38.642139°	38.642028°
				-121.620750°	-121.620667°
DWR ID	DWR_RD0827_02_f_2017_13				
Comment Code					
Inspector Comment					
Levee Evaluation Comments					
Description:					
Site ID No:199					
Site Designation:RD 827-01					
Repair Type: Erosion					
Rating:Area of Concern					
Field Date:6/6/2017					
Notes: landside. Visqueen has dried up and is no longer protecting the slope.

Updated view of sloughing on the landside slope. Fall 2018.

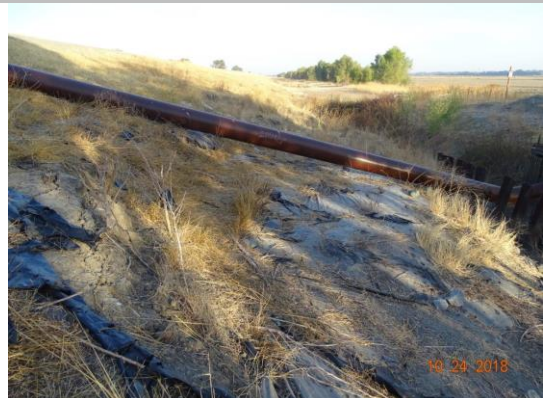
Photo 2 of 6 : FA_2018_RD0827_188_13_20181025_00022.jpg

View of visqueen placed by LMA adjacent to pump. Fall 2018.

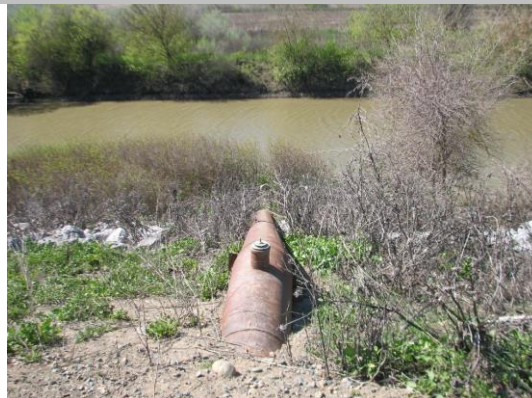
Photo 1 of 3 : UCIP_FA_2018_38984_59769.jpg

Comment Code						
Inspector Comment						
FS_ID:38984 DS_ID:21151 EP_NO: 3277 Repair Type: Non-Urgent Crossing Status: Found UCIP Comments: Crossing appears to have been removed and replaced under maintenance back in 2008. No permit has been found--need to contact owner to obtain additional information about replacement. Landward slope sloughing--does not appear to be associated with crossing. Landward slope is being monitored by LMA. FIELD_STRUCT_DESC: 18-inch (not 20-inch as noted in desk study) steel drainage pipe through the levee, 4 feet below the crown. Cutoff wall around pipe at center of levee. Siphon breaker on apex of pipe at waterside (WS) shoulder. Pump on pipe structure in drainage ditch at landside (LS) toe. Rock revetment on WS slope. (20-inch drainage pipe authorized under Permit No. 3277, 1960-Reclamation District No. 827; no permit found authorizing the 18-inch pipe) [Additional Reference(s): DWR Levee Logs, 2005] FS Date: 3/18/2014

View of pipe visible on waterward side.

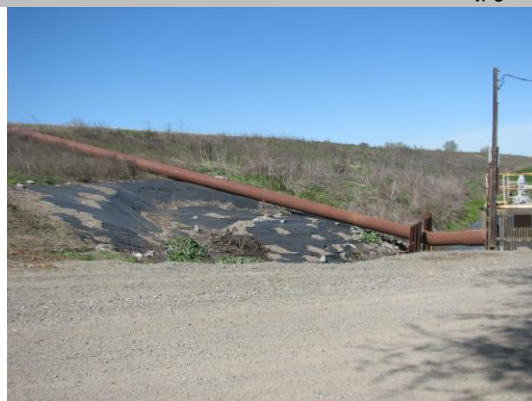
Photo 3 of 3 : UCIP_FA_2018_38984_59767.jpg

Comment Code						
Inspector Comment						
FS_ID:38984 DS_ID:21151 EP_NO: 3277 Repair Type: Non-Urgent Crossing Status: Found UCIP Comments: Crossing appears to have been removed and replaced under maintenance back in 2008. No permit has been found--need to contact owner to obtain additional information about replacement. Landward slope sloughing--does not appear to be associated with crossing. Landward slope is being monitored by LMA. FIELD_STRUCT_DESC: 18-inch (not 20-inch as noted in desk study) steel drainage pipe through the levee, 4 feet below the crown. Cutoff wall around pipe at center of levee. Siphon breaker on apex of pipe at waterside (LS) shoulder. Pump on pipe structure in drainage ditch at landside (LS) toe. Rock revetment on WS slope. (20-inch drainage pipe authorized under Permit No. 3277, 1960-Reclamation District No. 827; no permit found authorizing the 18-inch pipe) [Additional Reference(s): DWR Levee Logs, 2005] FS Date: 3/18/2014

Pipe exposed on landward side.

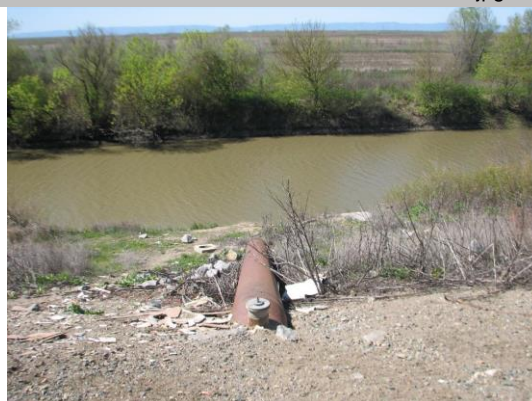
Photo 1 of 3 : UCIP_FA_2018_33032_59778.jpg

Comment Code						
Inspector Comment						
FS_ID:33032 DS_ID:21169 EP_NO: 5611 Repair Type: Non-Urgent Crossing Status: Found UCIP Comments: Crossing appears to have been removed and replaced under maintenance back in 2008. No permit has been found--need to contact owner to obtain additional information about replacement. FIELD_STRUCT_DESC: [RD No. 827 Pumping Plant] 22-inch (not 24-inch as mentioned in desk study) steel drainage pipe through the levee, 8 feet below the crown. Corrugated metal cutoff wall around pipe at center of levee. Siphon breaker on waterside (WS) slope. Flap gate on WS end. Pipe is exposed along WS slope. (portion of pipe was removed and replaced, from landside to waterside shoulder, under Permit No. 5611 (1968)). [Additional Reference(s): DWR Levee Logs, 2005. USACE Sacramento O&M Manual Unit No. 122 Part No. 1, August 1955, (Station 3+75)] FS Date: 3/18/2014

Pipe exposed on waterward side.
